# Acoustic emission and signal processing for fault detection and location in composite materials

## Abstract

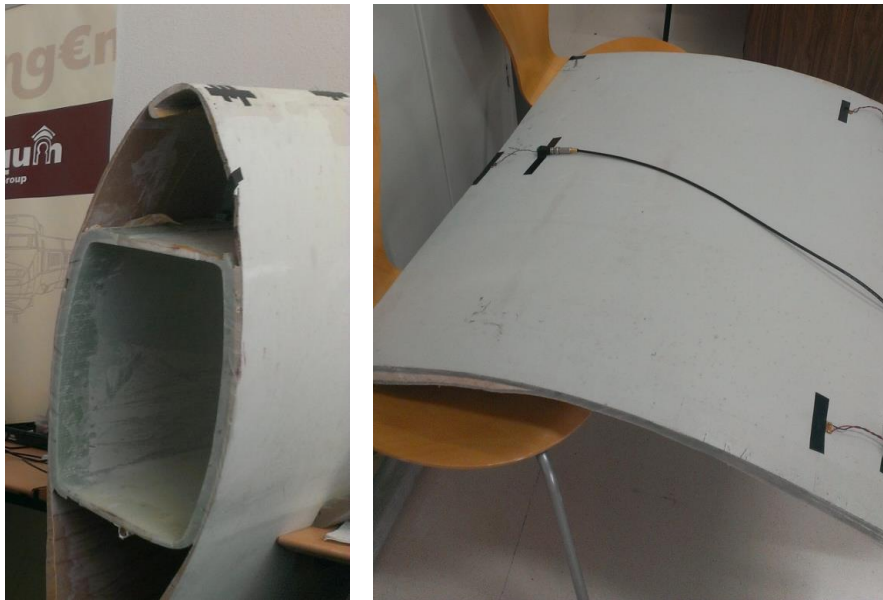
**Figure 1.** Blade fragments.

The experiments are performed on two pieces of a WT blade due to the inability to handle a full blade in the laboratory. The first fragment (see Figure 1, left), where an experiment for the detection of mud is performed, is made of glass reinforced plastic. This type of material has a versatile manufacturing, good structural properties and resistance to fatigue

among other advantages. It has also a low expansion coefficient and low electrical conductivity, making such materials particularly interesting for protection against lightning. Furthermore, composite materials are transparent to electromagnetic waves. The second fragment (Figure 1, right) consists of multiple layers. One of the ends is composed of a Honeycomb central layer embedded between two fibreglass layers made of polyester resin. The other end is thinner and assembled from two fibreglass layers. The remaining experiments are performed on it.

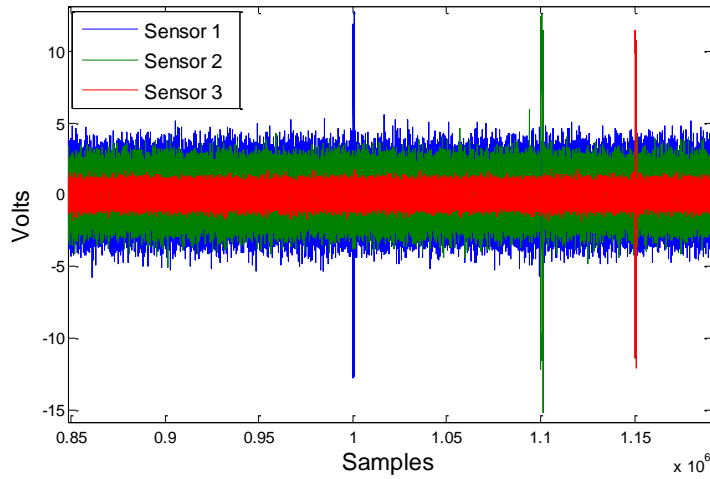
**Figure 2.** Crack delay signal simulations.

Several experiments are conducted to achieve the target. The acoustic emission produced by the division of the glass fibres is simulated by breaking the tip of the lead of a mechanical pencil. Previously, the emission rate needs to be calculated on the blade. Multiple tests are done applying the same force, angle of inclination and length for the lead. This is intended to get similar signals for all the case studies. As stated before, the raw data (Figure 2) will be filtered for a better processing and removal of unwanted frequencies.

The wavelet transform is introduced for this purpose. Wavelet transform is a tool applied to time and frequency domain analysis with the use of several decomposition coefficients at different frequency bands [15]. It can work with high and low frequencies, identifying spectral features, unusual temporary files, and lack of stationary and removing random noise [16]. The wavelet transform improves the limitations of resolution; and the loss of information presented by other filtering methods [17][18]. Research into leak detection in plastic pipes from acoustic emission signals [19], cracks [20] or evaluation of the corrosion on non-accessible pipes can be found [21] based on wavelet transforms.
